Review of Field Work and GIS Analysis To Date

Courteny Morehouse, Housatonic Valley Association

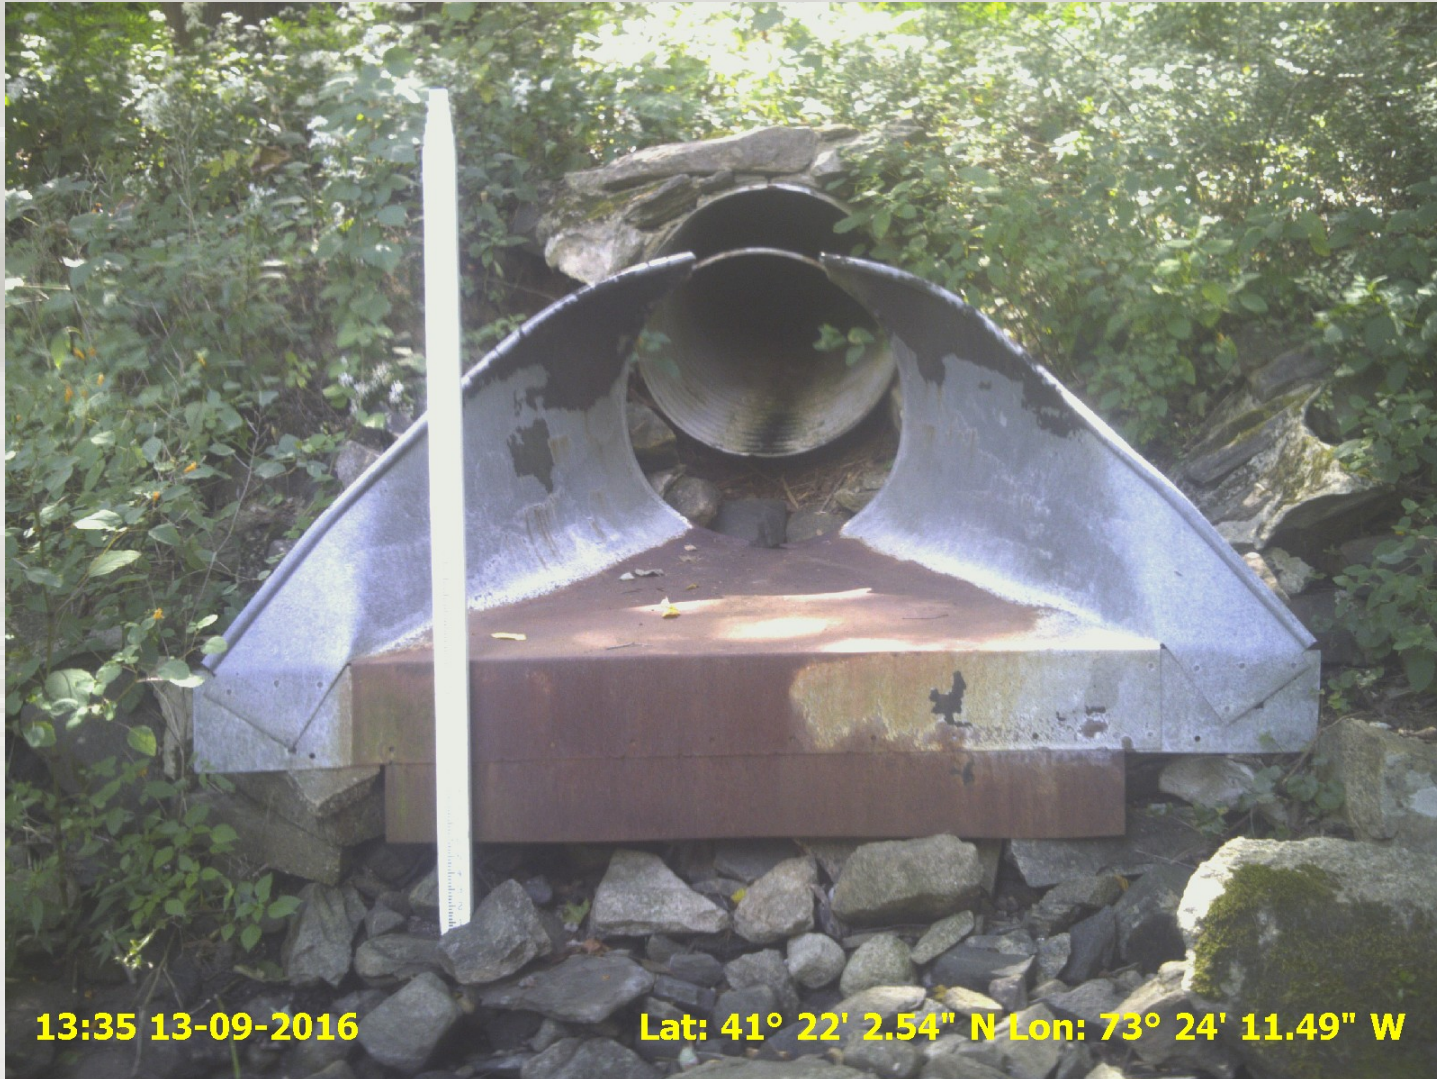
STORMWATER OUTFALLS (OT)

- 205 stormwater outfalls documented
- 17 tested for ammonia-nitrogen

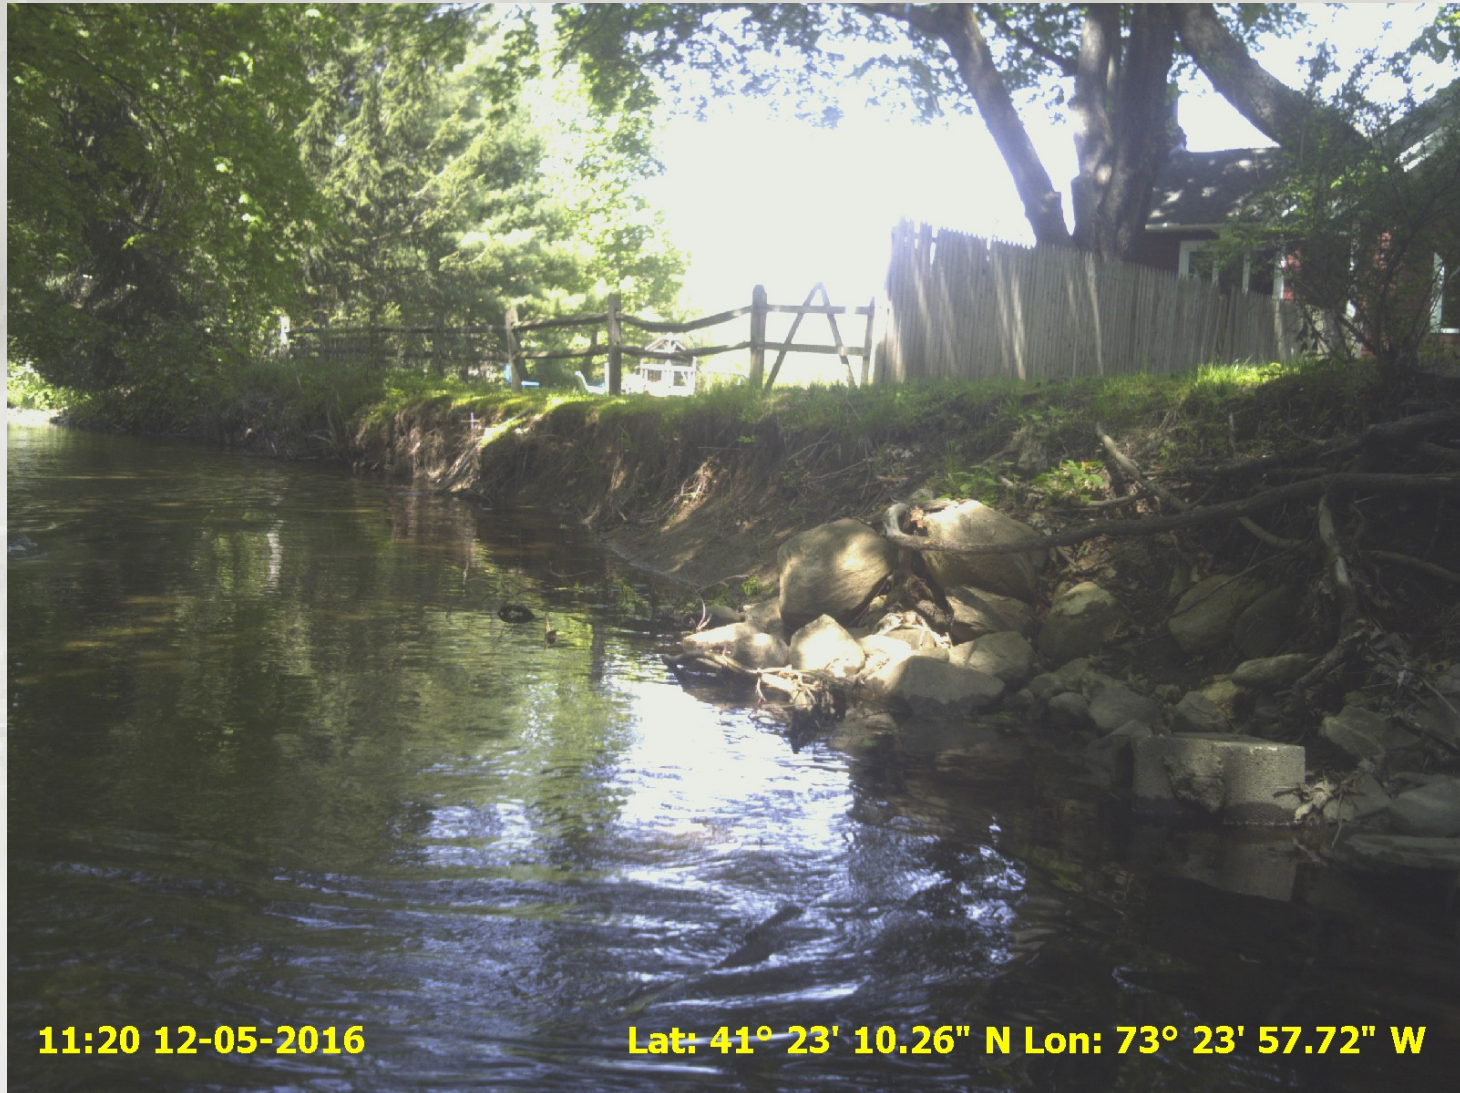
Impacted Buffers (IB)

- 2 miles of impacted buffers documented at 46 separate sites

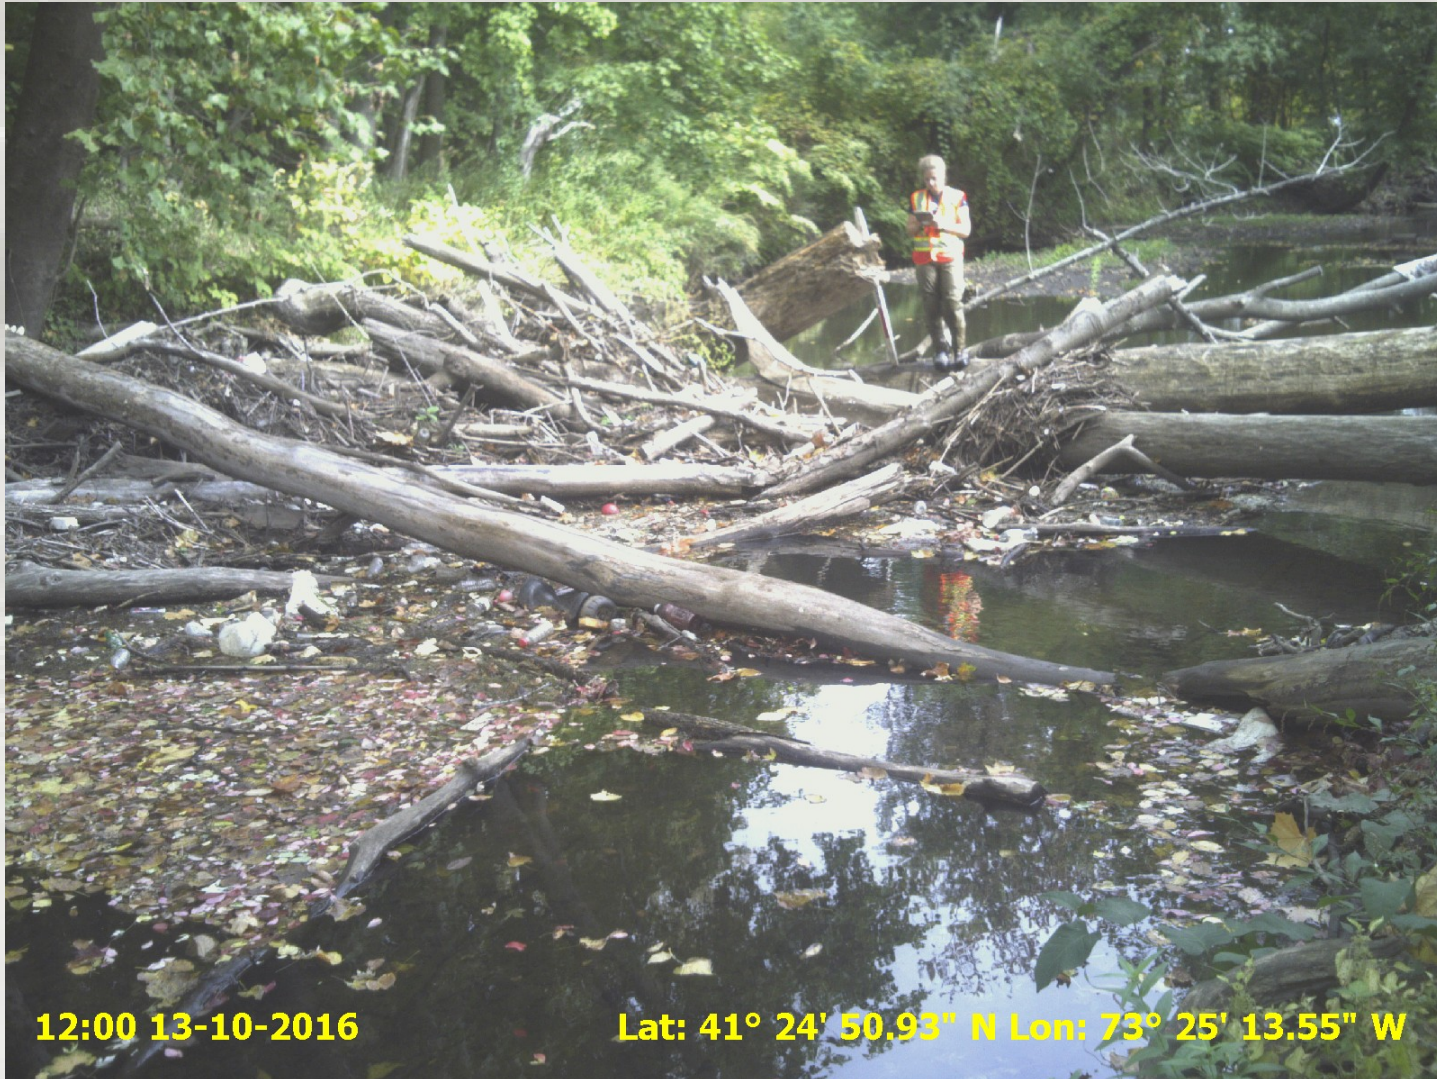
Trash and Debris (TR)

• 11 trash & debris sites documented, including:

- Large collections of garbage stuck on woody debris
- Lawn trimmings dumped into the river
- Small illegal streamside dumps

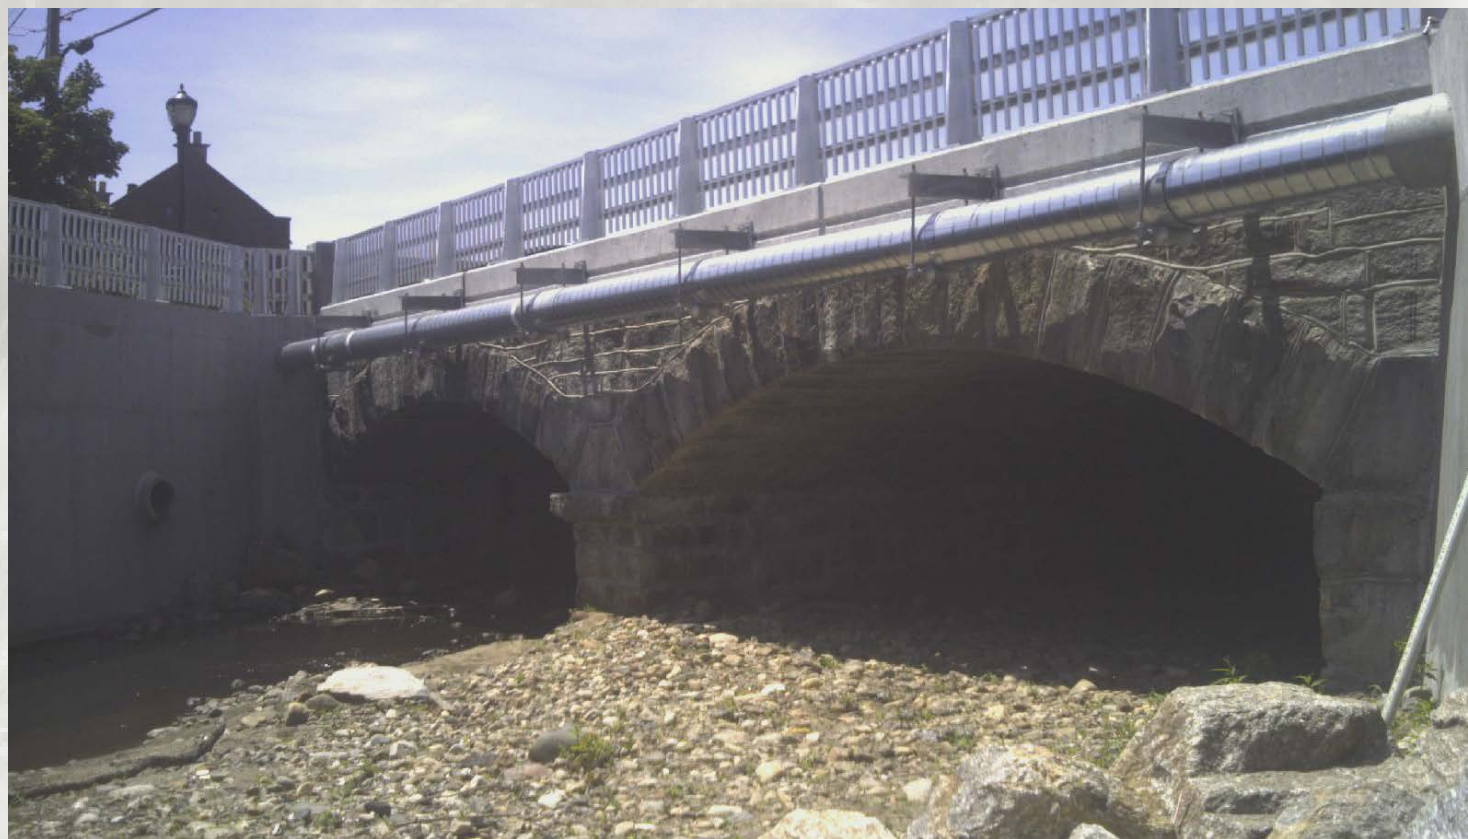
Stream Crossings (SC)

138 road-stream crossings have been documented and assessed using the North Atlantic Aquatic Conservation Collaborative method.

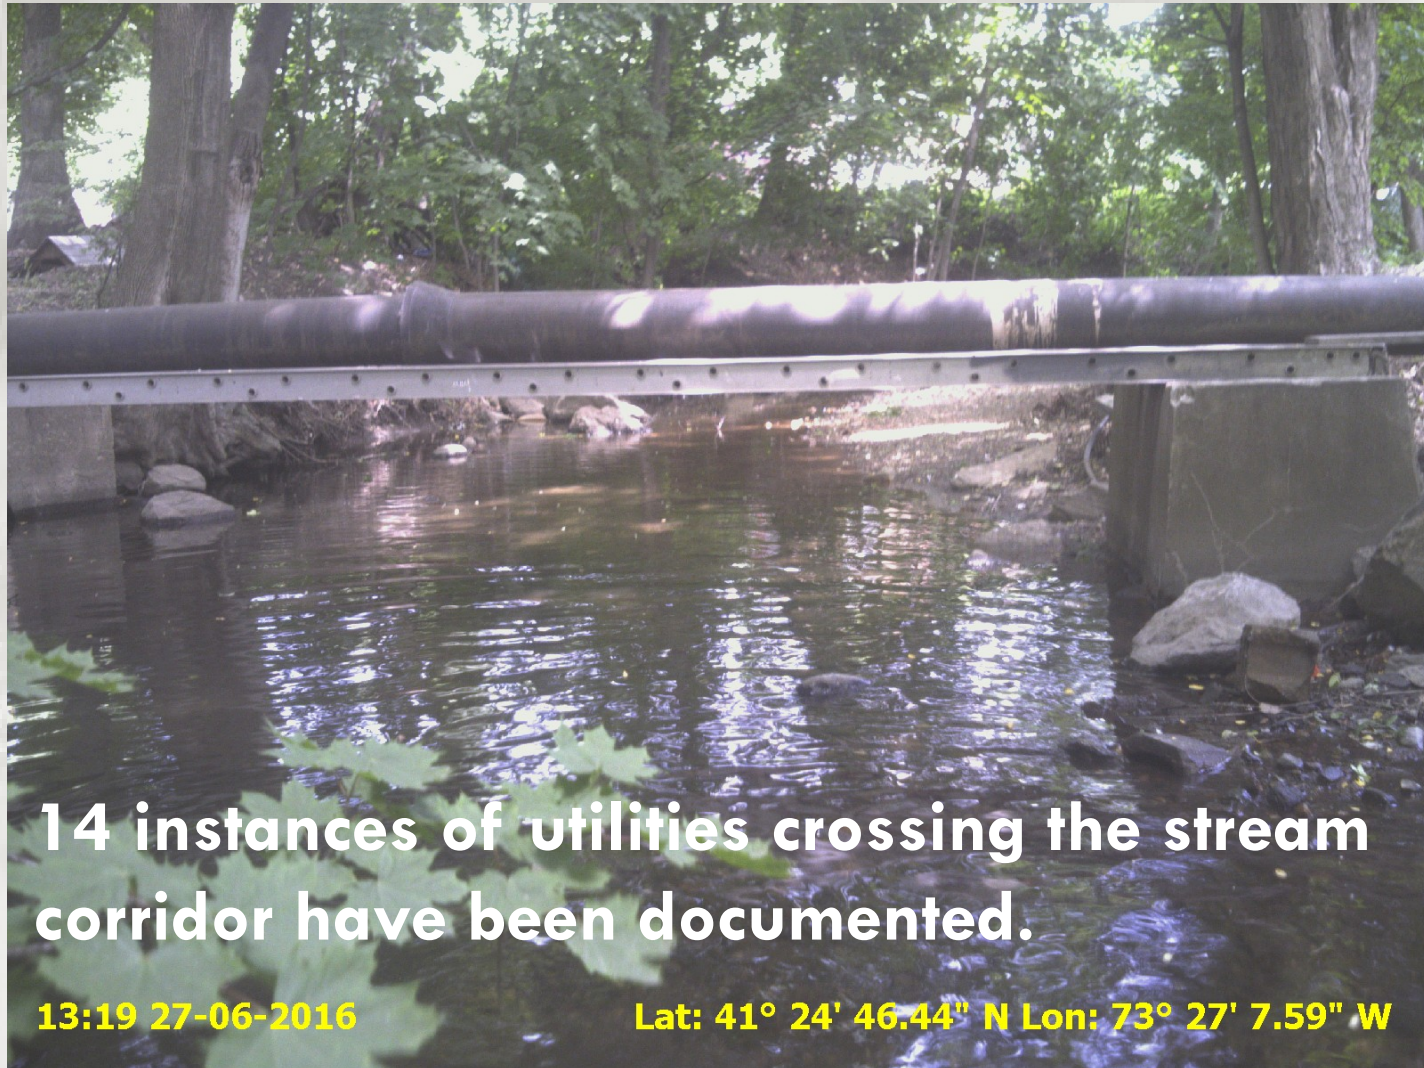
Utilities in the Stream Corridor (UT)

14 instances of utilities crossing the stream corridor have been documented.
