# Still River Watershed Draft Existing Conditions Report

*Prepared for*  
Connecticut Department of Energy and Environmental Protection

*In support of the*  
Still River Watershed Action Plan for Nonpoint Source Pollution Reduction  
(CT DEEP Contract #14-03f)

*Prepared by* Housatonic Valley Association  
150 Kent Road South  
Cornwall Bridge, CT 06754

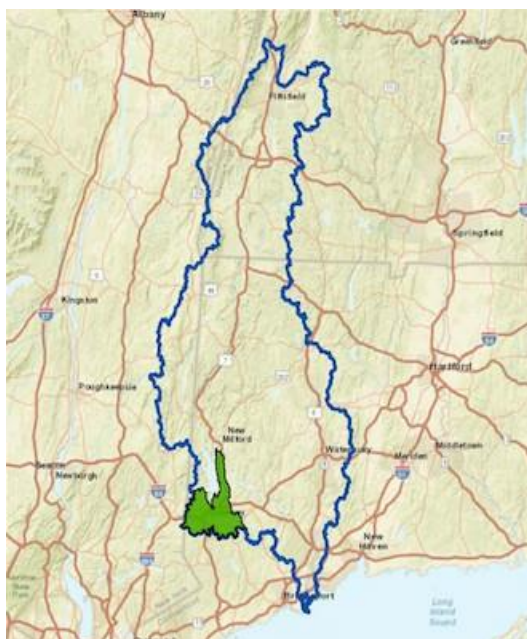
**Figure 1. Housatonic & Still River Watershed**

The Still River watershed includes portions of the communities of Bethel, Brookfield, Danbury, Newtown, New Fairfield, New Milford, Redding, and Ridgefield, CT in Litchfield and Fairfield counties. The major tributaries of East Swamp Brook, Limekiln Brook, Miry Brook, Padanaram Brook, and Sympaug Brook are confluent with the Still River mainstem. The Still River joins the Housatonic in New Milford, and waters from this largely urbanized area empty into Long Island Sound.

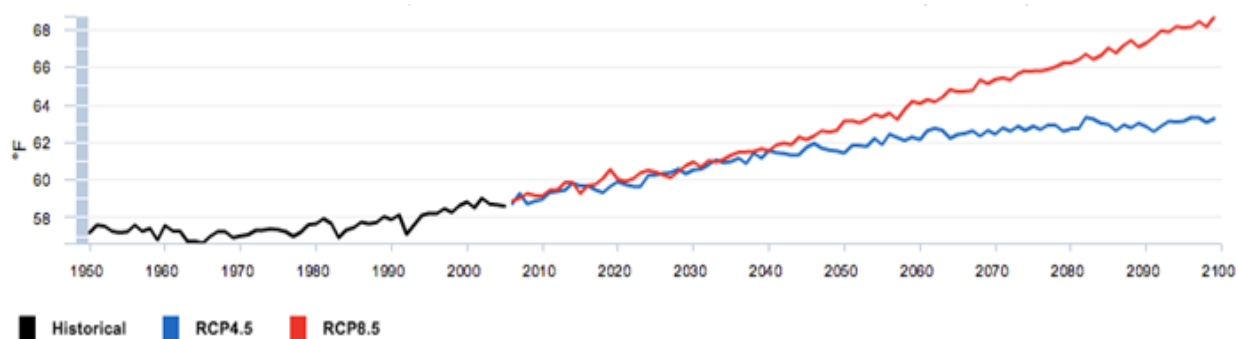
**Figure 2: Historical (1950-2005) and Projected (2006-2100) Max Temperature Change in Degrees F**

Highs (annual mean max temperature) have risen in the Housatonic Watershed since 1950 (black) and will continue to increase under both high (red) and low (blue) emission scenarios through the end of the century. Relative to the period 1981-2010, which saw an annual average high temperature of 58.1°F, in the period from 2025-2049 the watershed is projected to see warming of 2.9°F (low emissions)- 3.2°F (high emissions); by 2099 the warming increases to 5.2°F- 10.6°F. Although the warming is seen over all seasons, it is projected to be greater in summer months.<sup>11</sup>

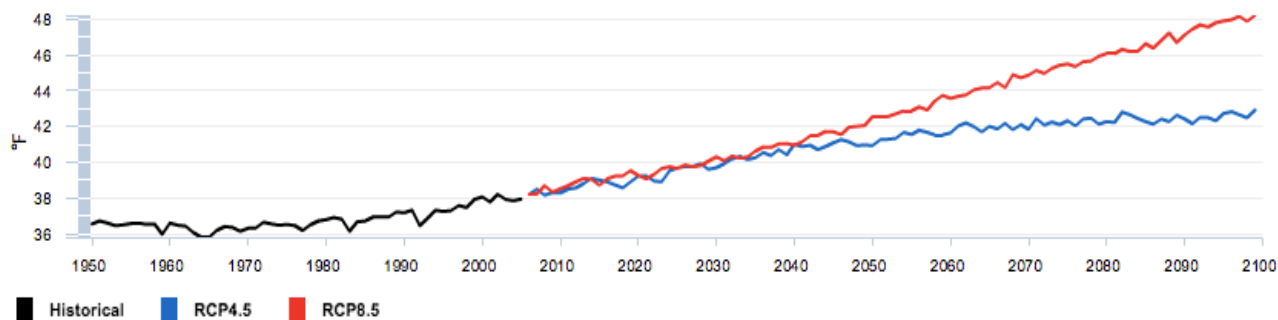
**Figure 3: Historical (1950-2005) and Projected (2006-2100) Min Temperature Change in Degrees F**

Lows (annual mean min temperature) are also projected to warm by similar margins as high temperatures, 2.9°F (low emissions) - 3.4°F (high emissions) for the period of 2025-2049. Whereas highs will see greater warming in the summer, lows will see greater increases in winter months. By the end of the century (2075-2099), January is projected to see a 5.9°F- 11.2°F temperature increase whereas July will see 4.7°F- 9.4°F. Winter warming affects the number of extreme cold days and makes the coldest days warmer. The coldest winters of the future will be closer to the warmest winters of recent years.<sup>12</sup>

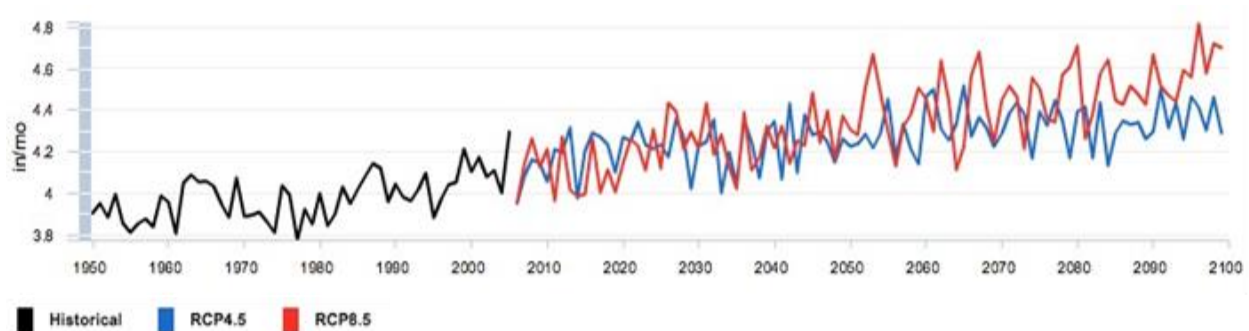
**Figure 4: Historical (1950-2005) and Projected (2006-2100) Mean Precipitation in Inches/Month**

Precipitation will increase moderately throughout the year, especially in winter and spring. Annual mean precipitation is projected to increase 5% from 4.0 in/mo in 1981-2010 to 4.2 in/mo in 2025-2049 under low emissions. By the end of the century (2075-2099) this average is projected to be 4.3 in/mo (low emissions)- 4.5 in/mo (high emissions). Combined with warming winter temperatures, much of this

increased precipitation will be seen as rainfall in the winter, increasing the runoff in the winter and spring and decreasing it in the fall.<sup>13</sup>

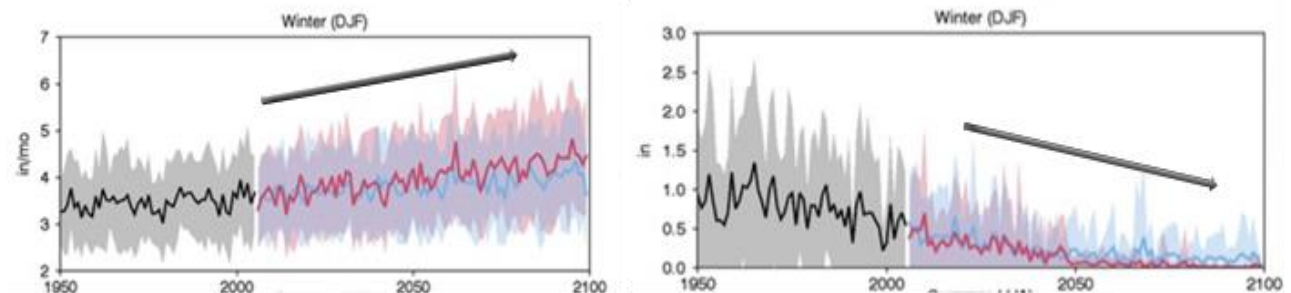
**Figure 5: Increasing winter (DJF) precipitation (left) and decreasing winter snow water equivalent (right) historically (1950-2005) and projected (2006-2100)**

The snow water equivalent is the liquid water in inches that is stored in snowpack. Under both high and low emissions, the snowpack is decreasing in the Housatonic River Watershed throughout the 21<sup>st</sup> century. As seen in Figure 5, winter precipitation has increased and will continue to increase while the winter snowpack decreases. In general, increasing temperatures result in more precipitation falling as rain than snow. Snowpack is a strong control of seasonal runoff and less storage as snowpack combined with increases in precipitation as rain will result in more runoff instead of storage and earlier snowmelt, which affect the timing and magnitude of the hydrograph.<sup>14</sup>

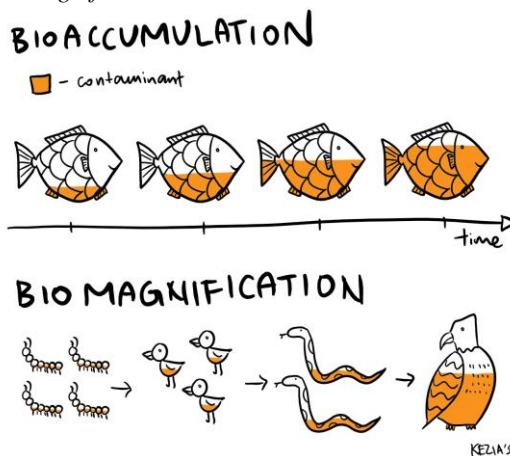
*Bioaccumulation is the increase of a contaminant in a single organism over time. For example, fish eat mercury contaminated macroinvertebrates. Because mercury doesn't leave the fish's system, the more bugs it eats the more mercury bioaccumulates. This can then lead to biomagnification.*

*Biomagnification is when a contaminant, such as mercury, increases as it moves up the food chain.*

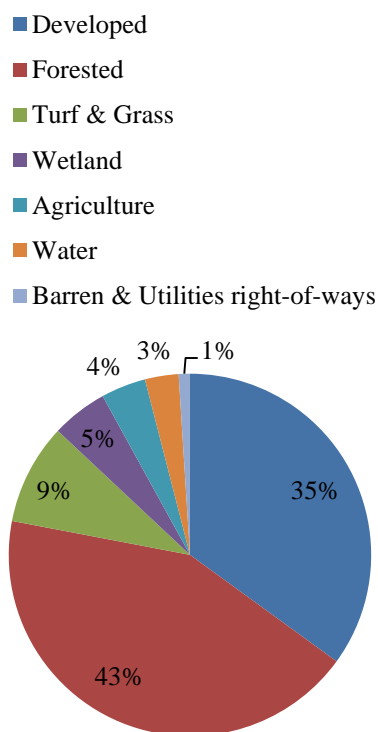
Figure 7: Still River Watershed Percent Landcover

The Still River watershed is considered a highly urbanized watershed. With over 14% impervious cover, 35% of the watershed land is developed (Appendix B, Still River Watershed Landcover). The remaining 65% is mostly forest but includes turf, wetland, agriculture, water, and some barren or utility right-of-ways (See Figure 7: Still River Watershed Percent Landcover).<sup>56</sup>
