Review of Field Work and GIS Analysis To Date

Courteny Morehouse, Housatonic Valley Association

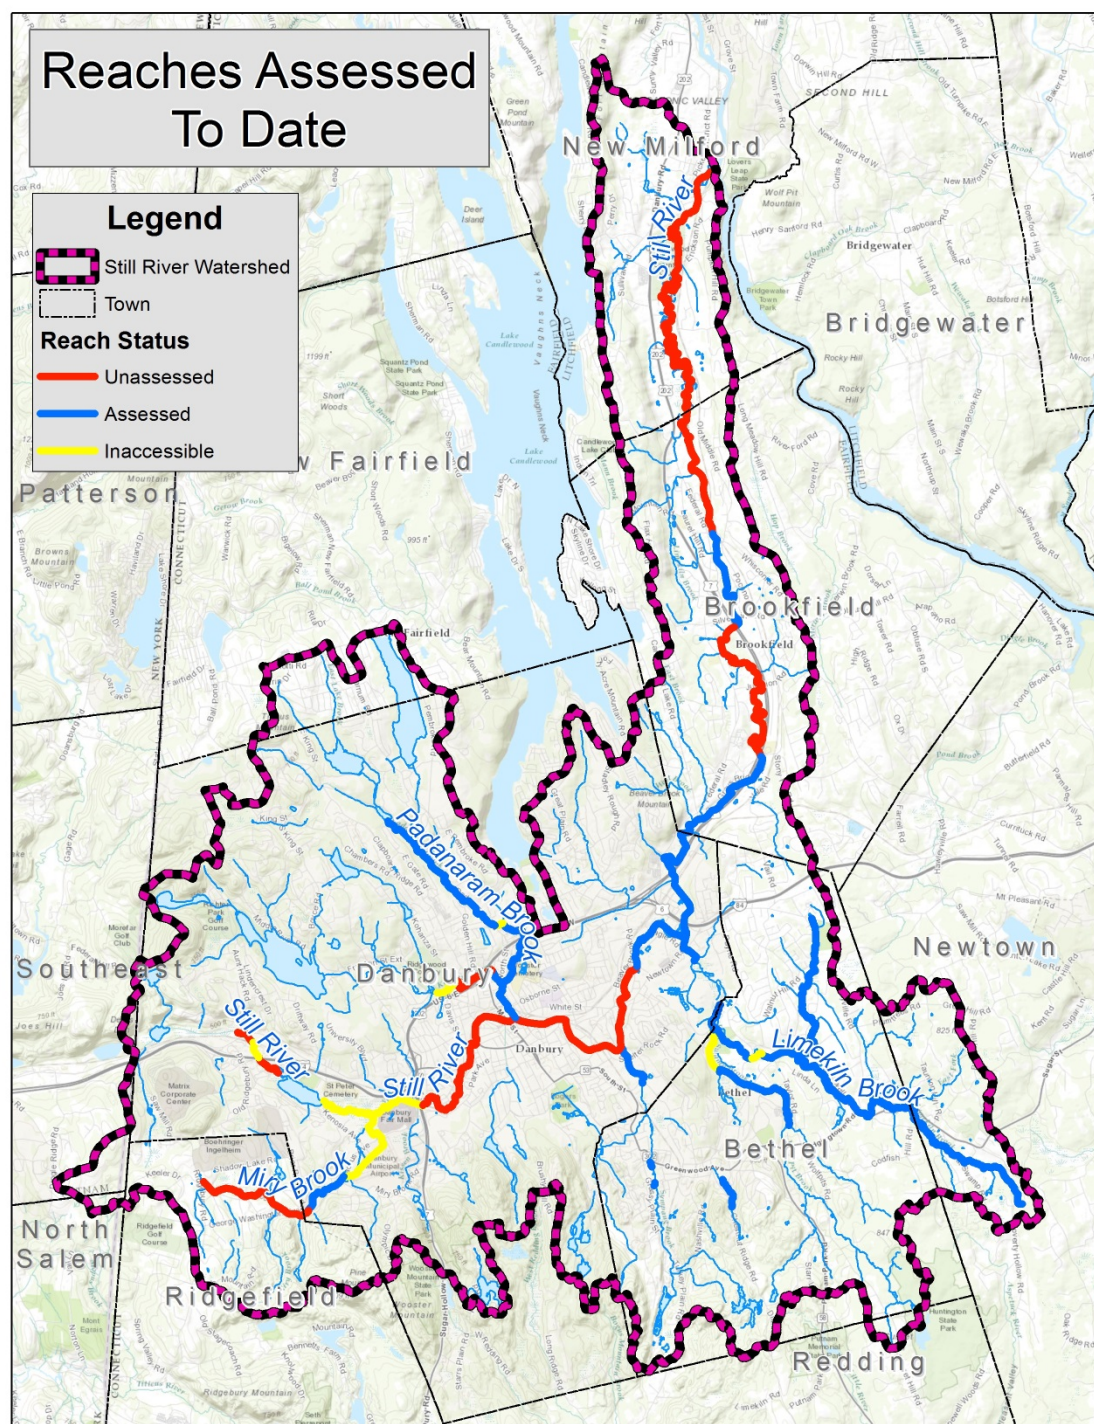
Reaches Assessed To Date

- Total Miles Assessed: 27
- Total Miles Inaccessible: 4
- Total Miles: 43
- Percent Completed: 64%

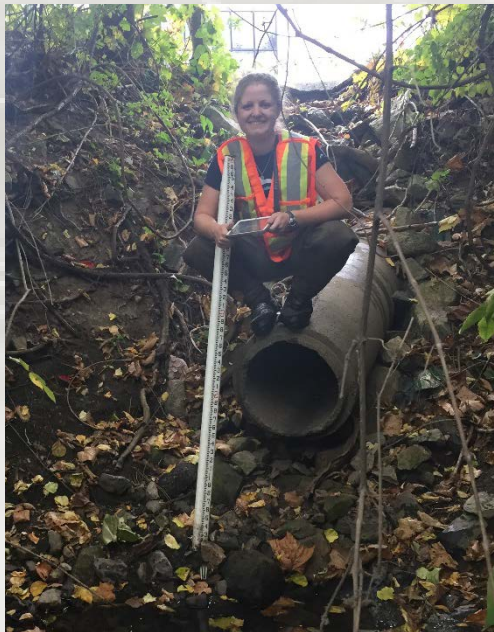
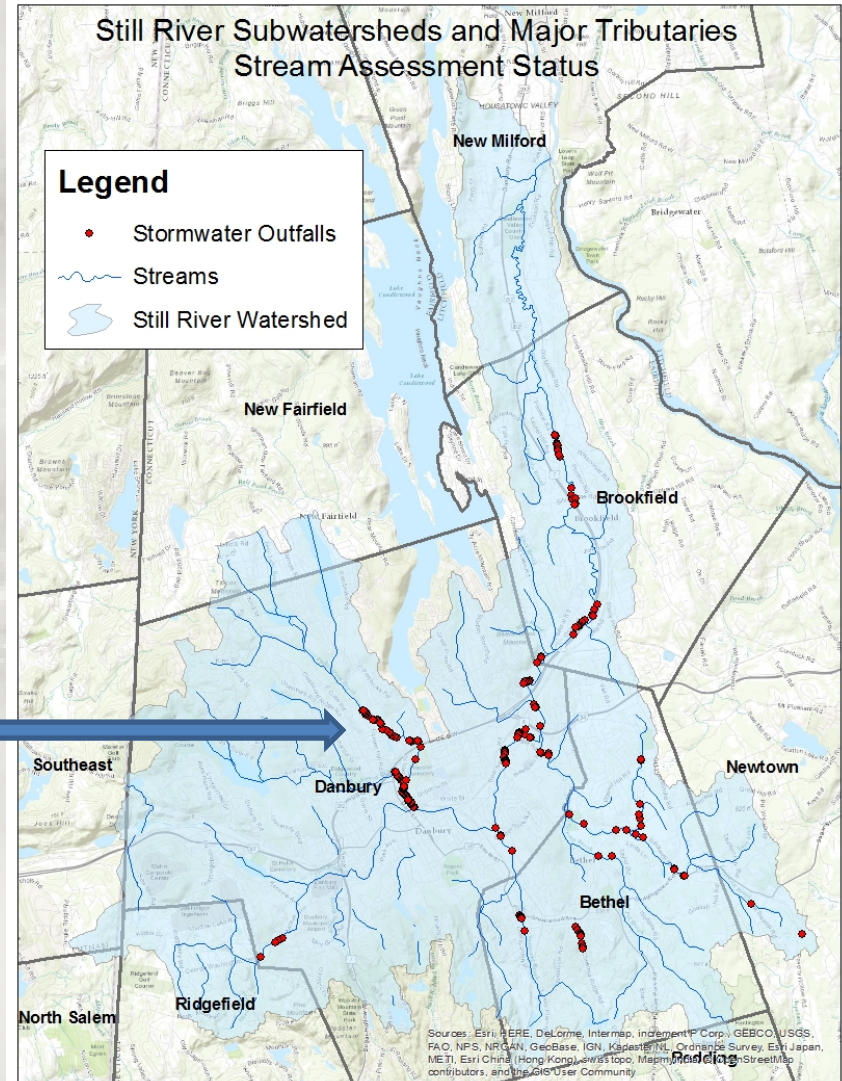
STORMWATER OUTFALLS (OT)

- 205 stormwater outfalls documented
- 17 tested for ammonia-nitrogen

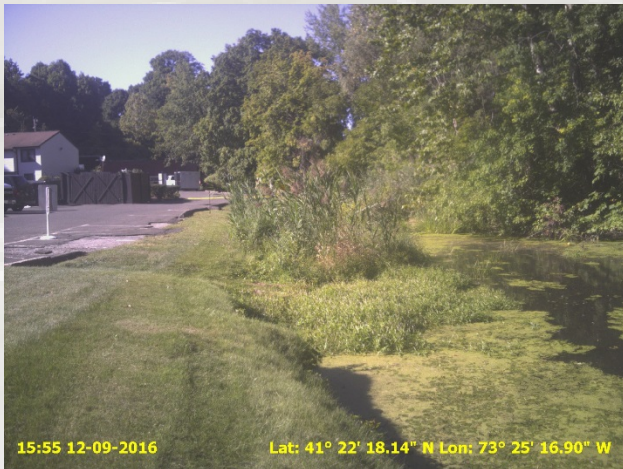
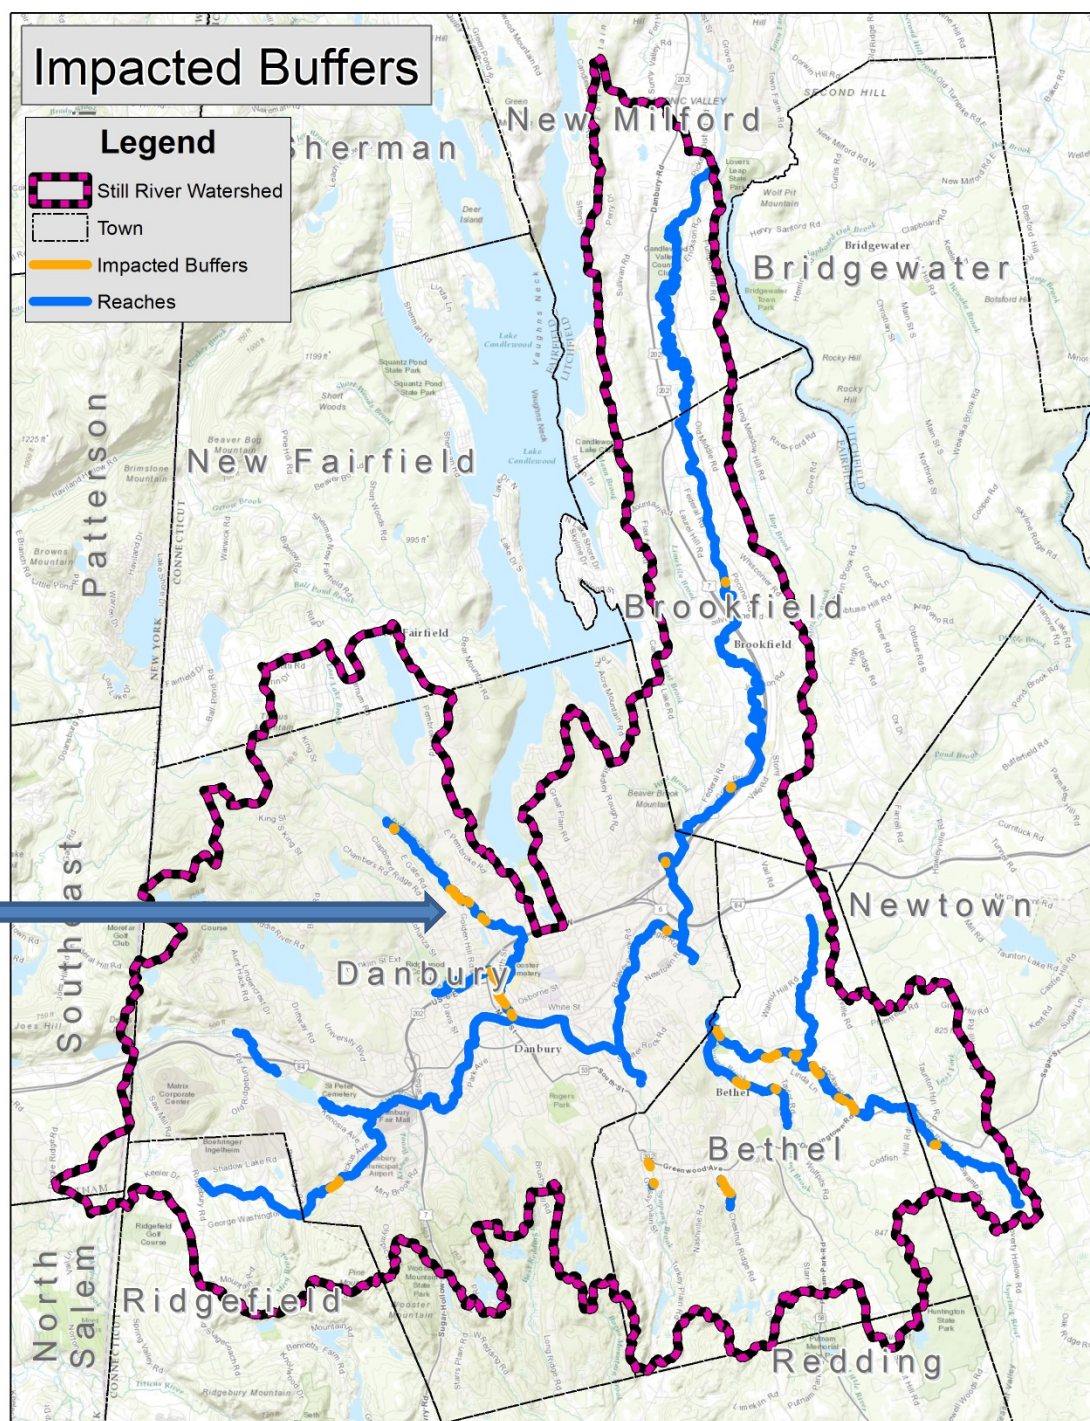
Impacted Buffers

- 2 miles of impacted buffers documented at 46 separate sites

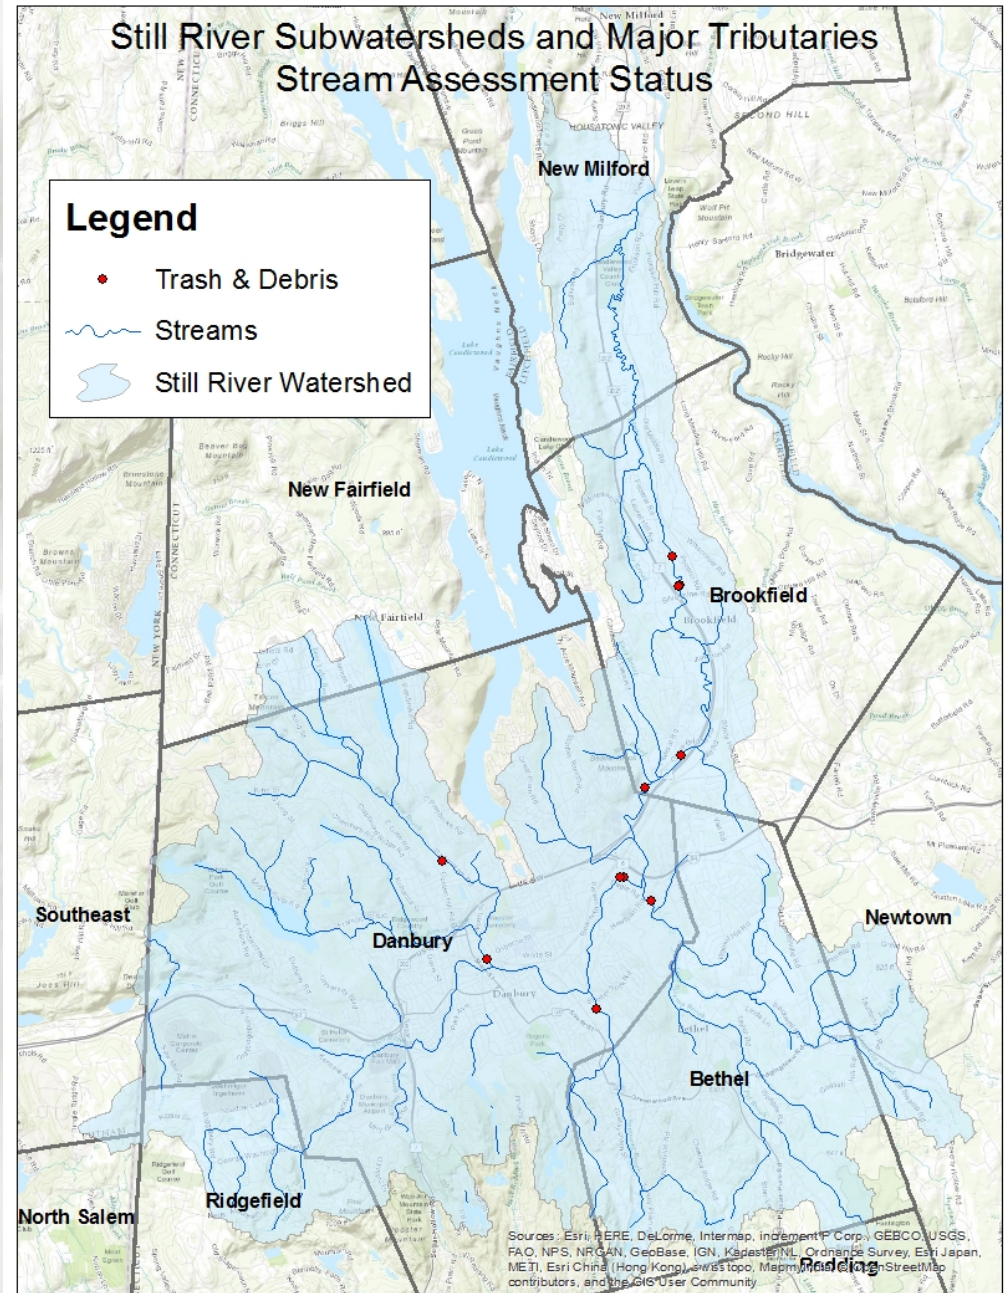
Trash & Debris

• 11 trash & debris sites documented, including:

- Large collections of garbage stuck on woody debris
- Lawn trimmings dumped into the river
- Small illegal streamside dumps
